# Safety Inspection Report

## Recreation Field

Box Parish Council

31 October 2023

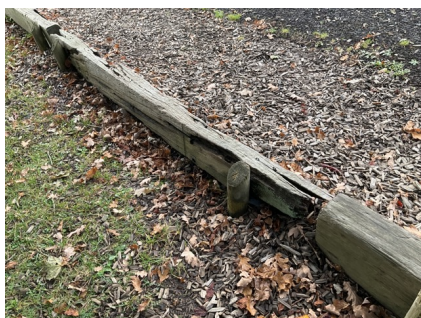
Timber is decayed.

Sleeper edging to bark pit.

Replace affected parts.

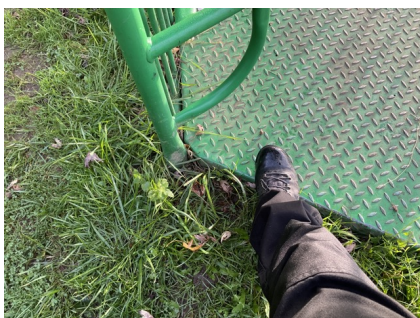
Fixtures loose or missing.

Floor panel is moving.

Tighten/replace.

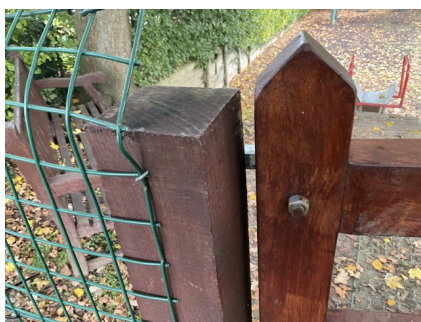
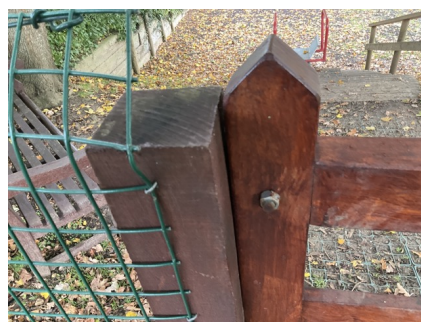
There is a crushing or shearing point on the side of the gate. Where the gaps reduce to less than 12 mm these have been known to cause serious, permanent injury to children, especially on the hinge side where the leverage forces are significant.

Adjust gate / posts / fit new rubber buffer to ensure a spacing of at least 12 mm throughout the range of the gate to remove the entrapment. The 12 mm gap also should apply on the hinge side of the gate.

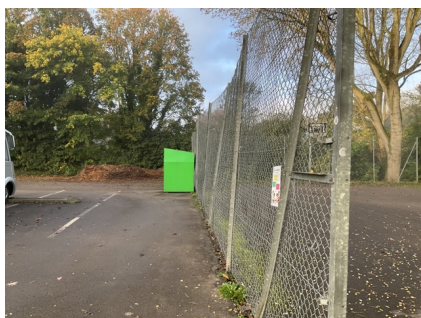
Item is bent.

Monitor posts.

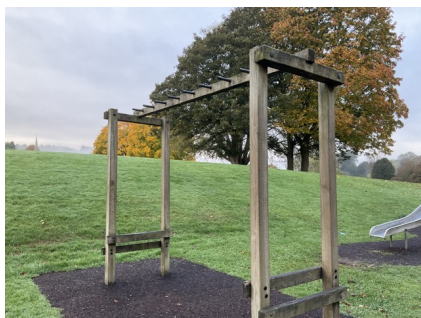
RoSPA is concerned by accidents on some types of overhead ladders and rings. However, there is a strong development value in these items.

The protective surface under all bars and rings must be kept in good condition.

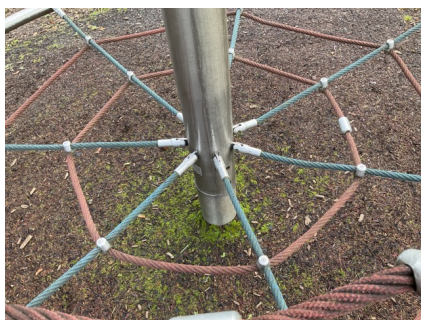
Fixtures loose or missing.

Upper rotating mast rocks.

Tighten/replace.

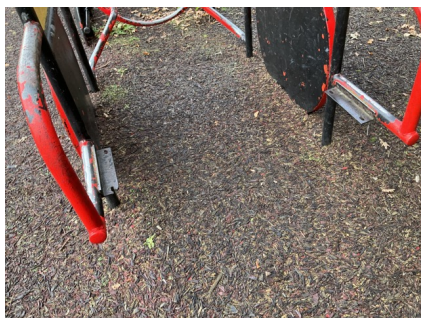
Item has some parts missing.

Replace the missing parts.

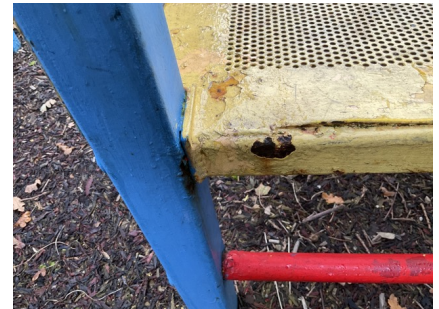
There is significant corrosion on this item.

The blue steps are very corroded with sharp edges underneath. Movement in the steps. Corrosion in the frame. The repair does not support the step.

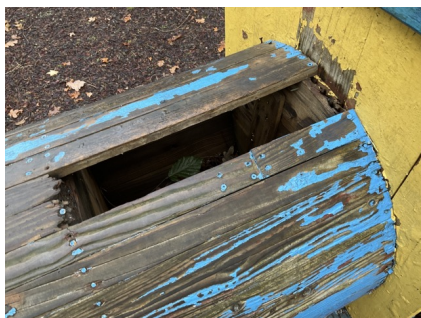
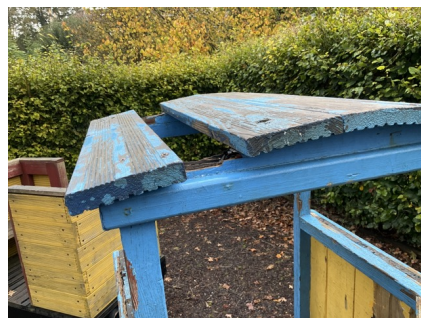
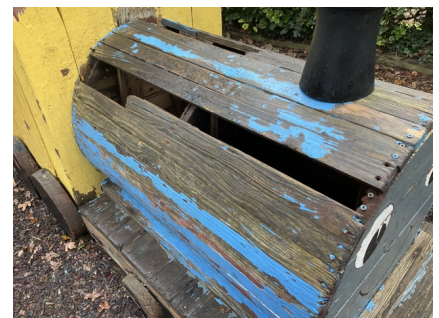
Moderate repairs are needed.

Repair.

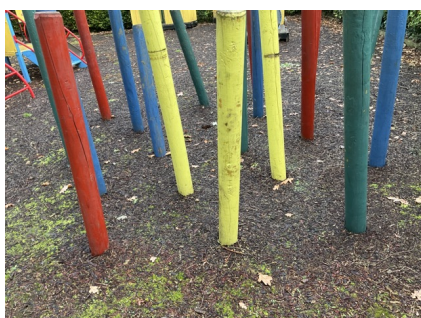
Loose in ground.

Some poles are loose but at the time of the inspection could no longer be pulled out of their holes. Monitor.

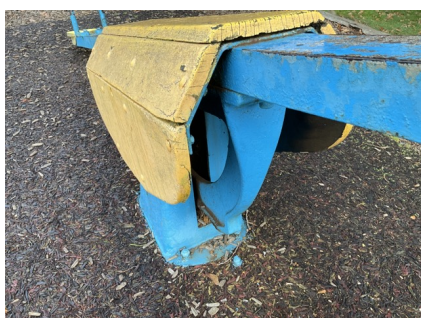
There are crushing points in the open mechanism. Replace the item.

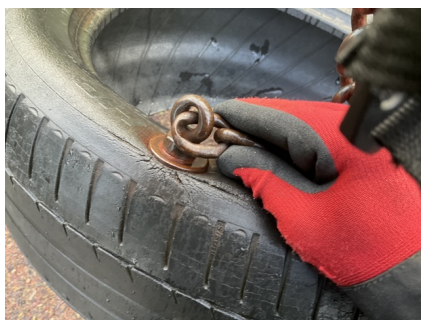
Some chain wear.

Replace end links.

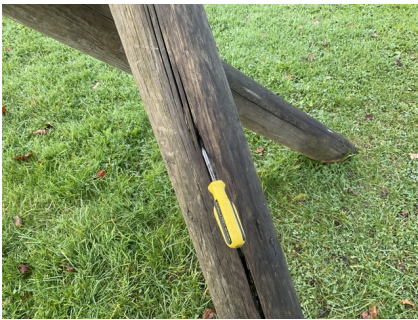
Timber is decayed.

Soft spots in air cracks.

We recommend resistograph testing to determine the internal condition of the timber. We can undertake this testing at additional cost. Please contact us for details.

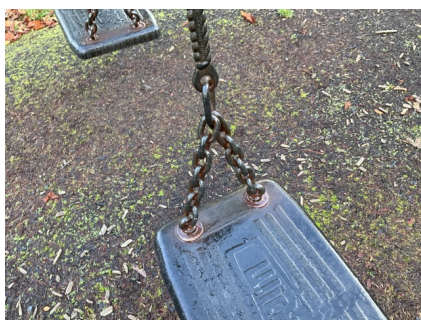
Some chain wear.

Monitor for further deterioration and replace before 40% wear.

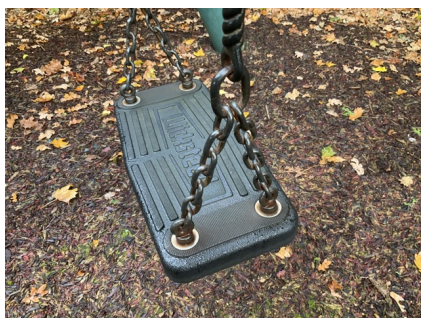
Some chain wear.

Monitor for further deterioration and replace before 40% wear.
