# Safety Inspection Report

## Recreation Field

Box Parish Council

31 October 2023

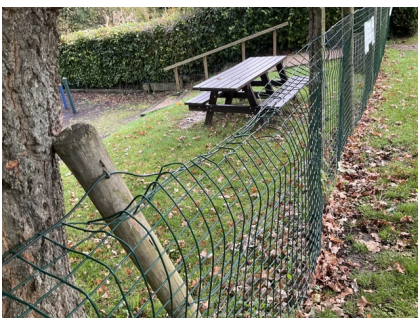
# Fencing

Minor repairs are needed.

Repair.

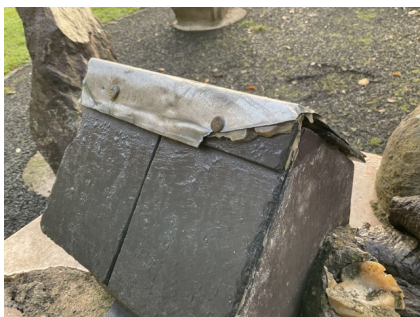
# Sculpture Box Rocks - Circle

Item is damaged.

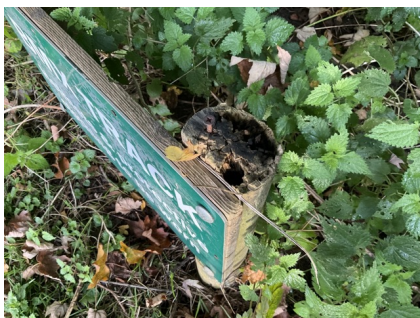
# Signage - BMX

Timber is decayed.

Replace affected parts.

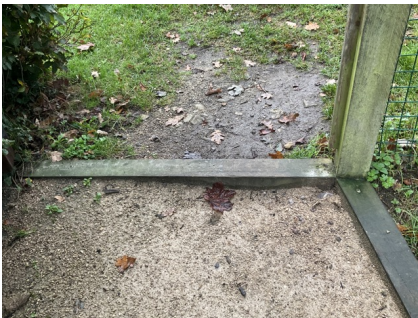
# Gates - Pedestrian

There is a crushing or shearing point on the side of the gate. Where the gaps reduce to less than 12 mm these have been known to cause serious, permanent injury to children, especially on the hinge side where the leverage forces are significant.

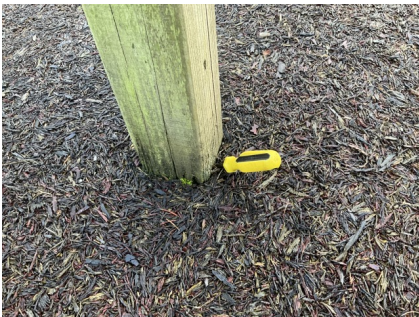
# Climber - Overhead - Pegs

Timber is decayed.

Replace affected parts.

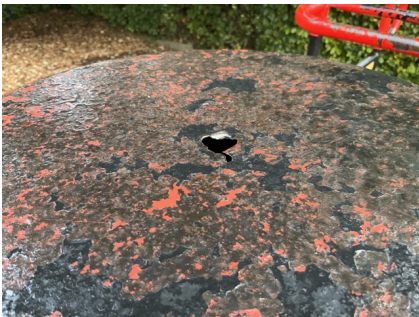
# Climber - Train

Item has some parts missing.

Replace the missing parts.

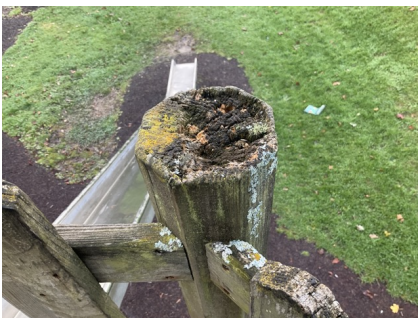
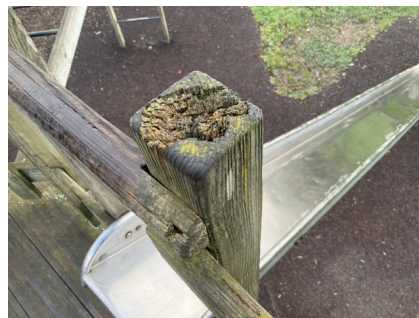
Timber is decayed.

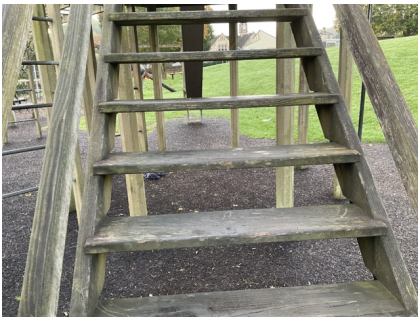
Access fails the entrapment requirements.

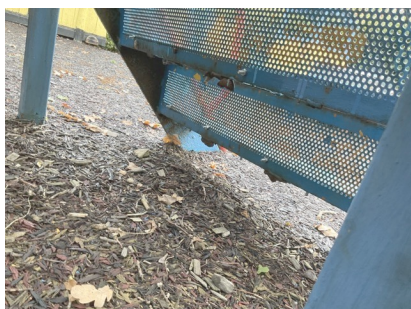
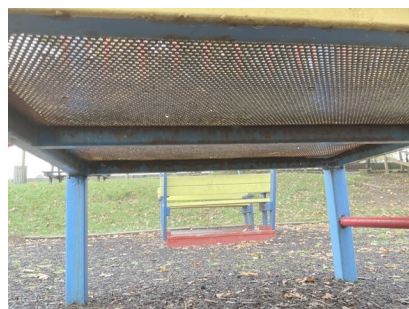
There is significant corrosion on this item.

The blue steps are very corroded with sharp edges underneath. Movement in the steps. Corrosion in the frame. The repair does not support the step.

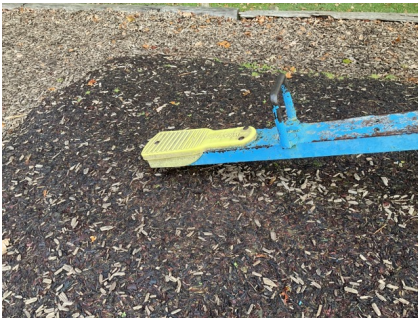
There are crushing points in the open mechanism. Replace the item.

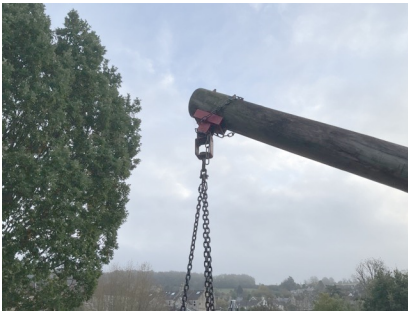
Fixtures loose or missing.

Replace.

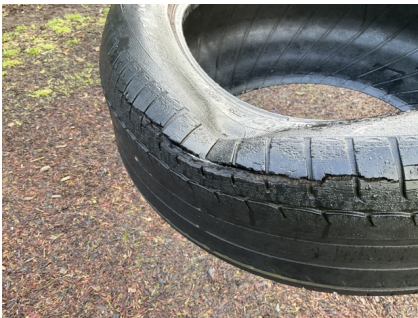
This equipment relies on one post for its stability. Special attention should be paid to maintenance (e.g. by monitoring degradation) and if necessary decommissioning the item before the end of its operating life.

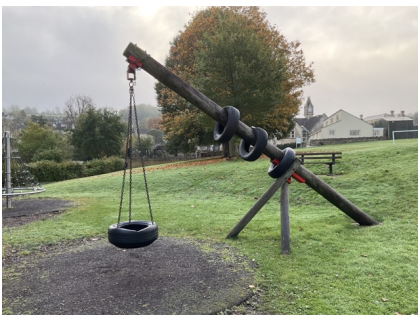
Timber is decayed.

Soft spots in air cracks.

We recommend resistograph testing to determine the internal condition of the timber. We can undertake this testing at additional cost. Please contact us for details.

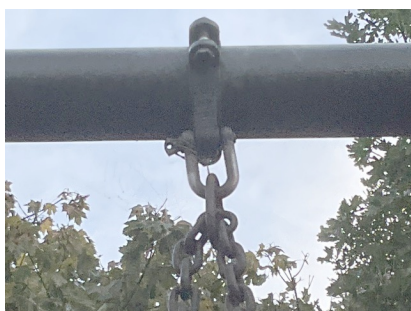
There is wear in the bushes.

Remove shackle bolt and check bush and shackle pin wear, replacing as necessary.

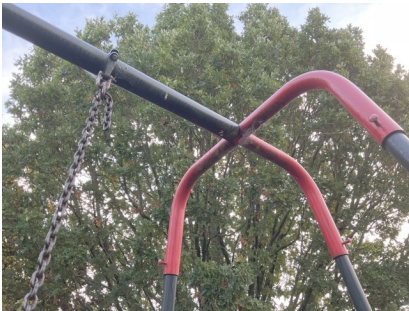
Fixtures loose or missing.

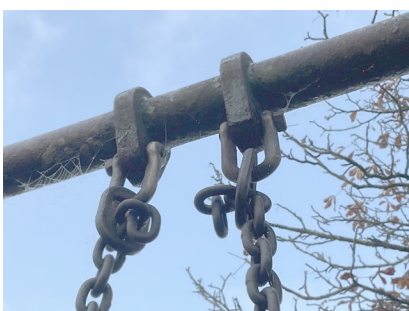
Item has corrosion.

Treat and repair.

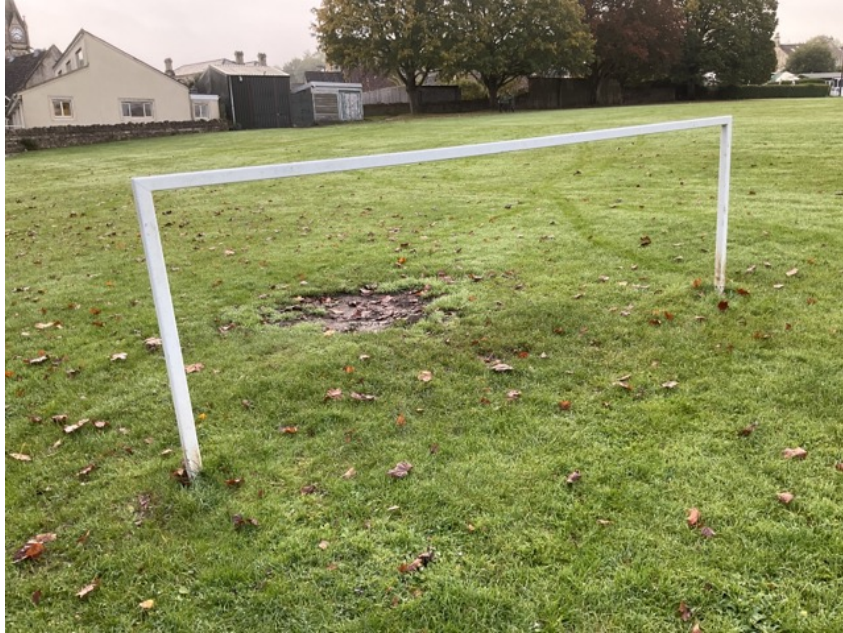
# Football Goal - Youth, Small-sided, Mini-Soccer or Futsal

**Risk level:**  
Medium

Repair the worn areas.

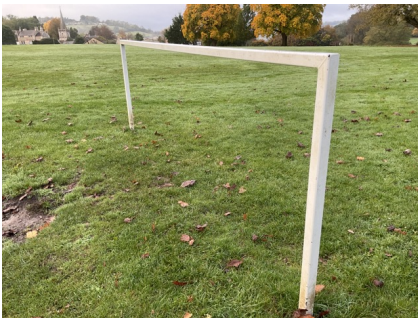
Loose in ground.
